URGENT Field Safety Notice

M5071A (adult) and M5072A (infant/child) pads for use with HS1/OnSite/Home AEDs may experience gel separation and reduction of gel surface area

21-FEB-2022

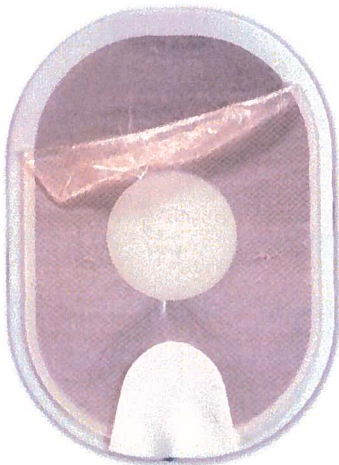
When a pad with separated, folded gel is placed on the patient's bare skin, the HS1/OnSite/Home AED could deliver less effective or ineffective therapy to the patient due to the reduced surface contact area with the skin. See example picture in **Figure 1**.

Figure 1: Separated gel that has folded onto itself when peeled.

Action:
Apply pads to the patient.
Do not hesitate.
